VEHICLE ACCIDENT INVESTIGATION

CASE NO. 90-08

[REDACTED], ARKANSAS

TECHNICAL REPORT

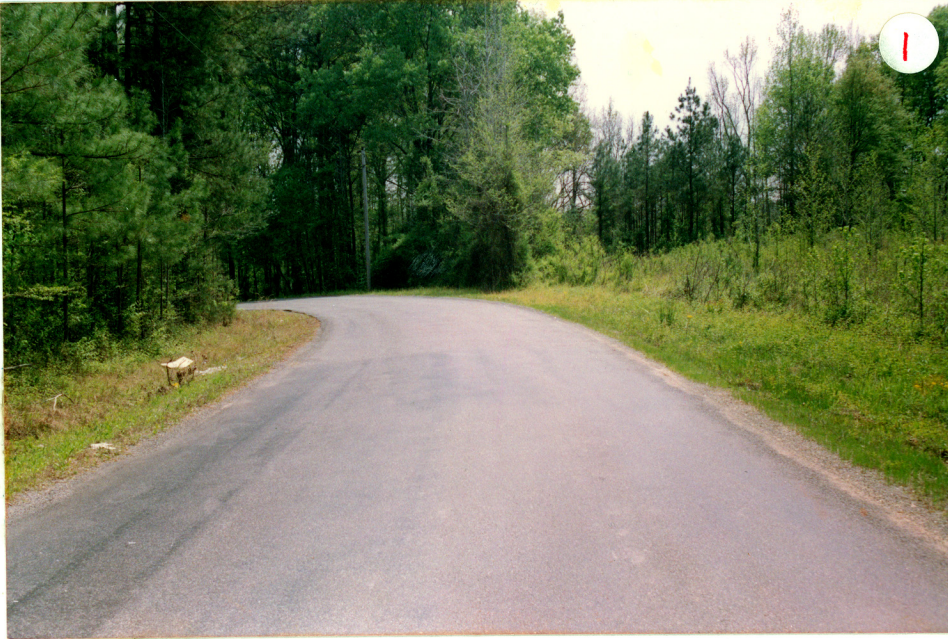
1. Pre-impact direction of travel of the Storm on Road.

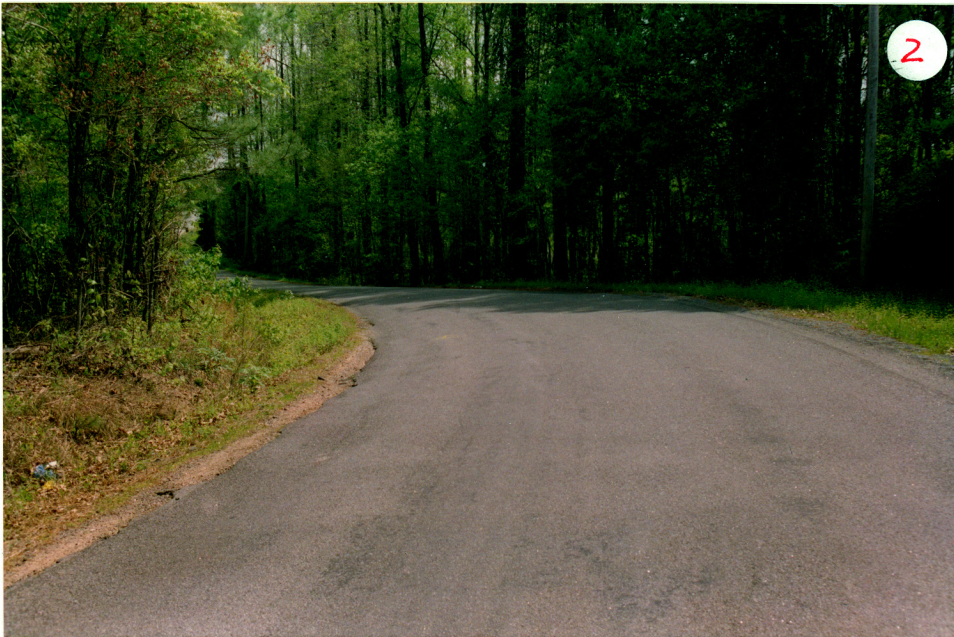
2. Consecutive view of the travel path of the vehicle.

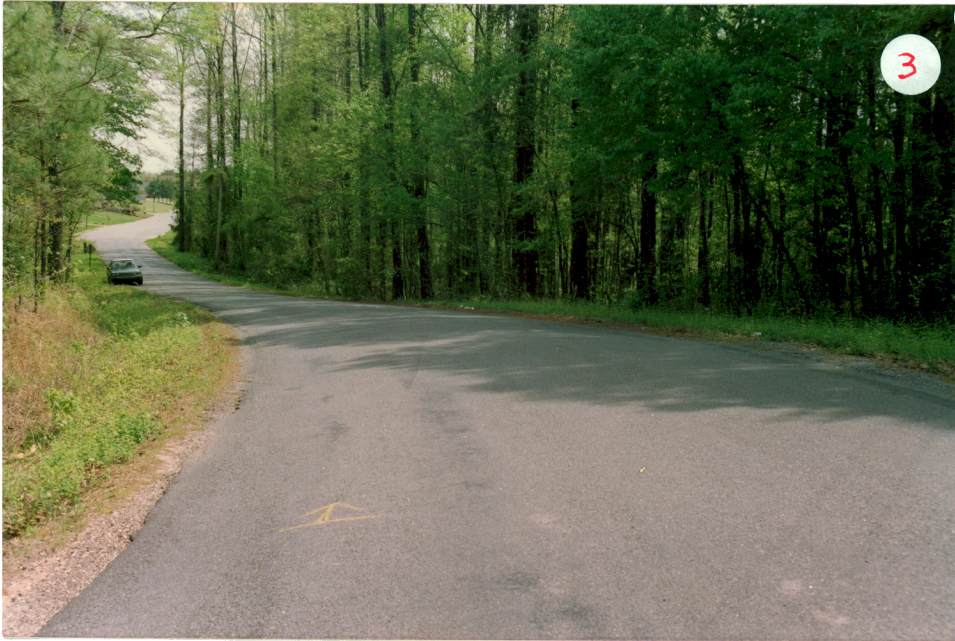
3. Area where the left front skid mark begins.

Evidence at the scene indicates the left front tire of the case vehicle skidded 97.25 ft. on the roadway. The vehicle traveled 36 ft. on the roadside before impacting the first group of small trees. The front bumper impacted at least three small trees in this area with the damage distributed across the entire frontal plane of the vehicle.

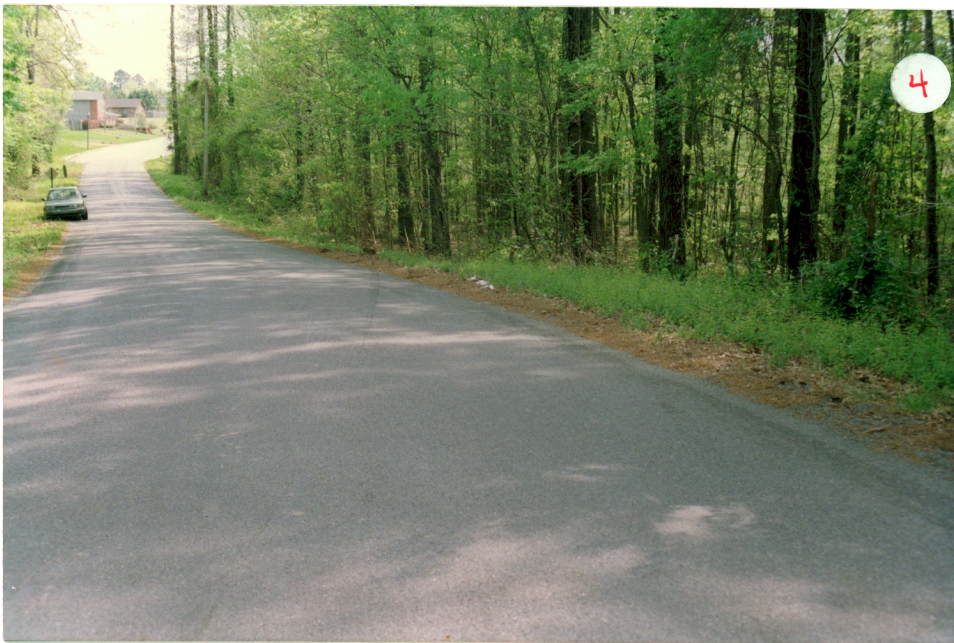
4. Continuation of the left front skid mark.

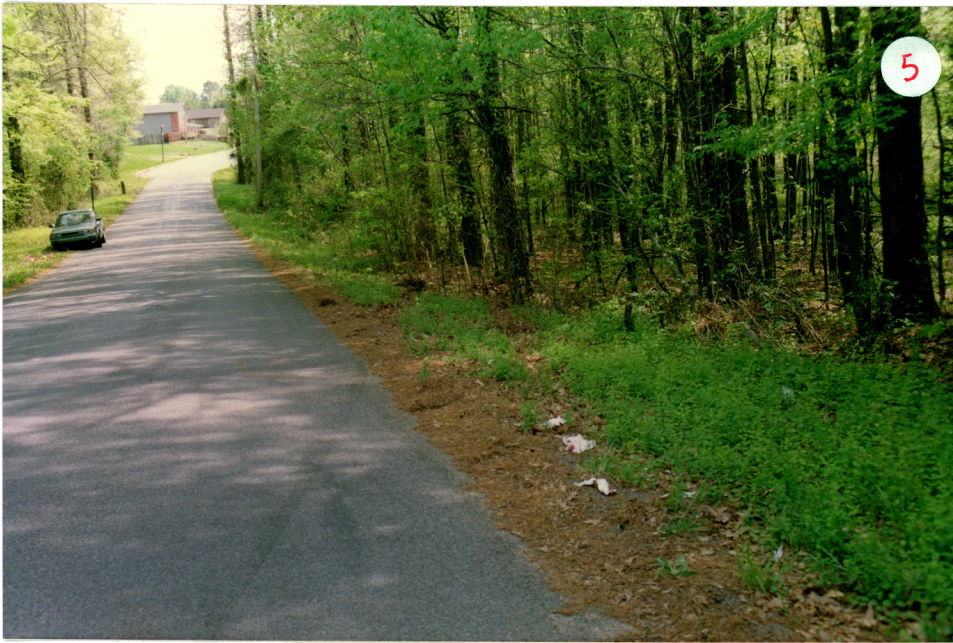
5. Area where the vehicle departs the roadway.

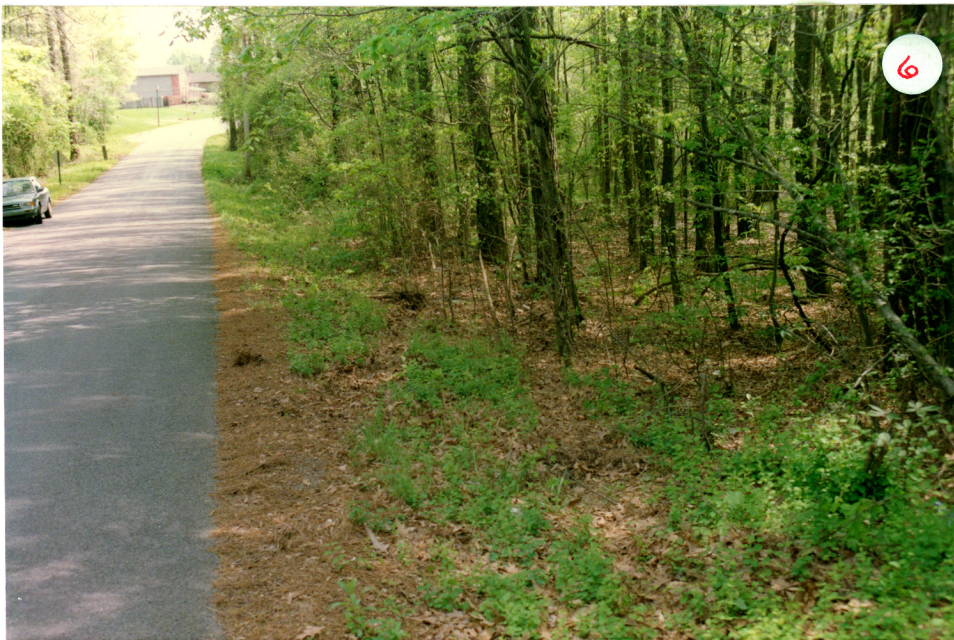
6. Path of travel of the vehicle on the roadside.

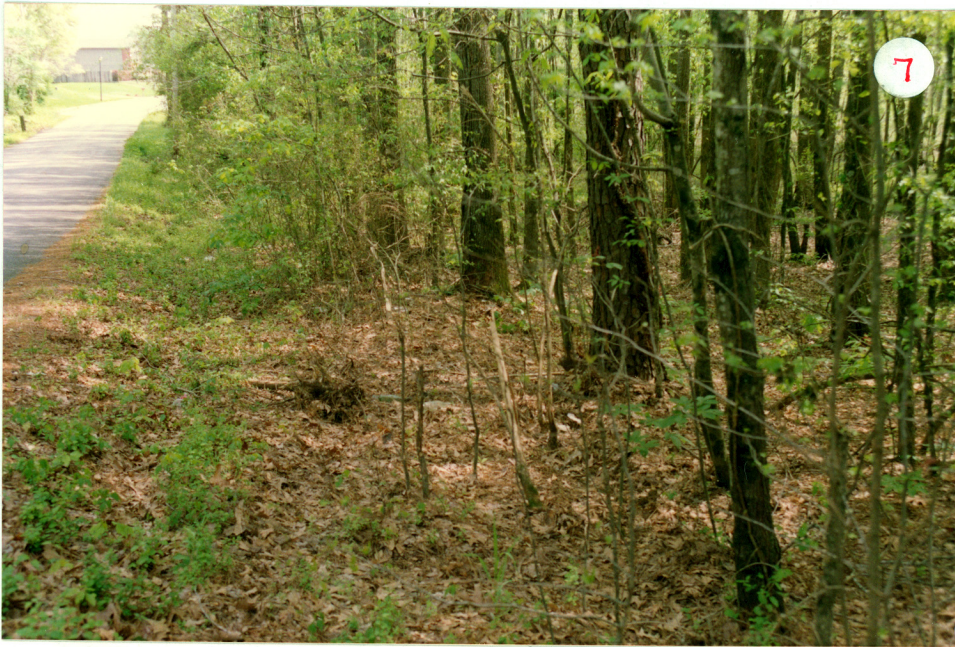
7. View of the area where the Storm impacts several small trees.

The frontal plane of the airbag vehicle impacted several small trees after leaving the roadway. Direct damage from the small trees was distributed across the entire front bumper cover. This damage did not result in enough crush to measure and a Collision Deformation Classification of 12-FDEW-1 was assigned to this impact.

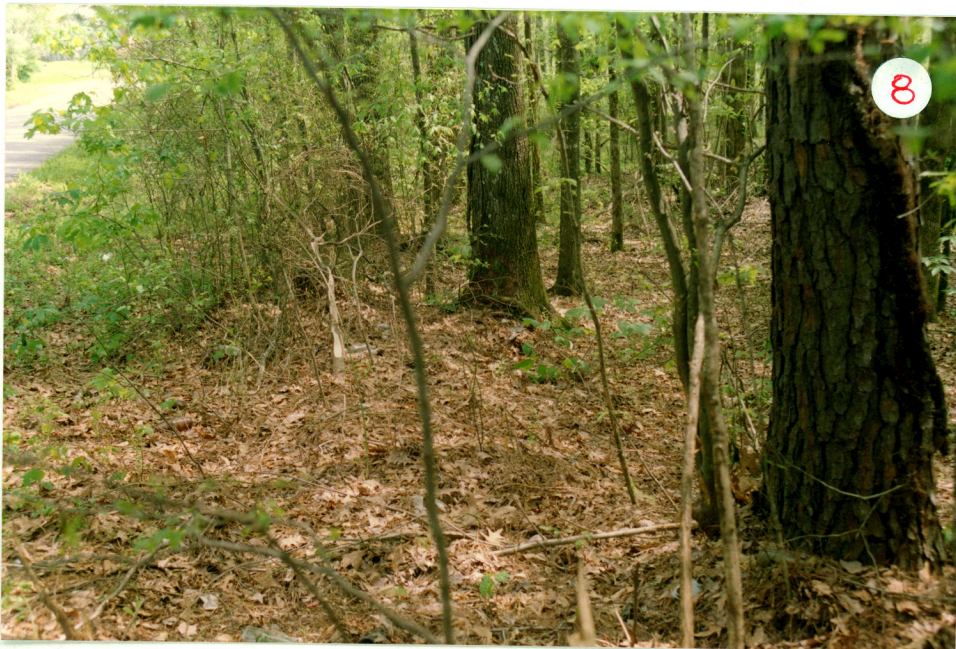
8. View of a large pine tree sideswiped by the vehicle.

The next significant impact was with a larger tree. The right side of the vehicle sideswiped a pine tree. Damage was noted to the right front fender, right front tire and rim, right side door, right side mirror, and right rear quarter-panel from this impact. Again measurable resultant crush was too small to measure. A Collision Deformation Classification of 12-RDAS-1 was assigned to this sideswipe damage.

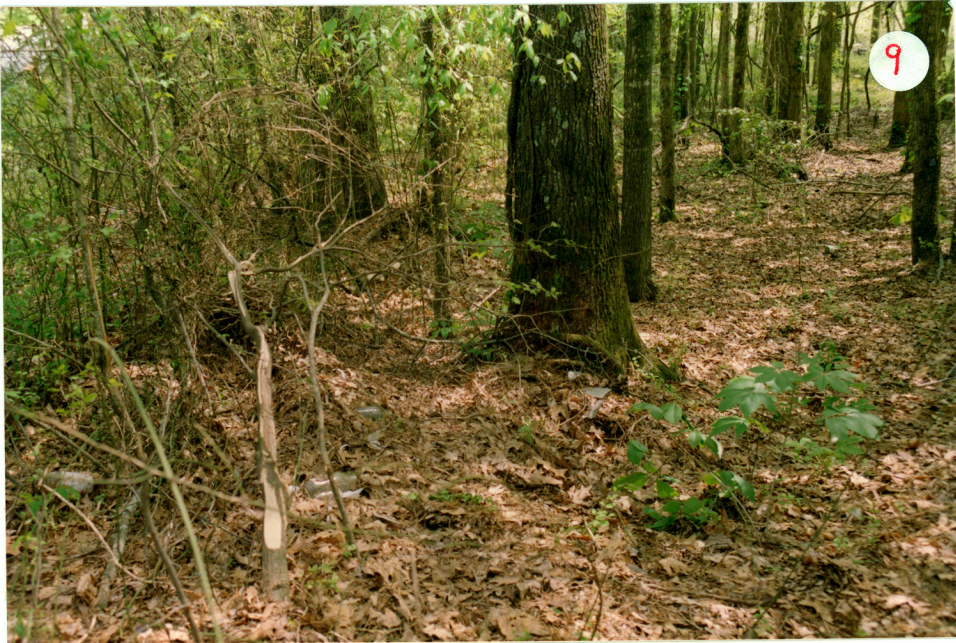
9. Continuation of the vehicle's path to impact with another small tree and a large tree.

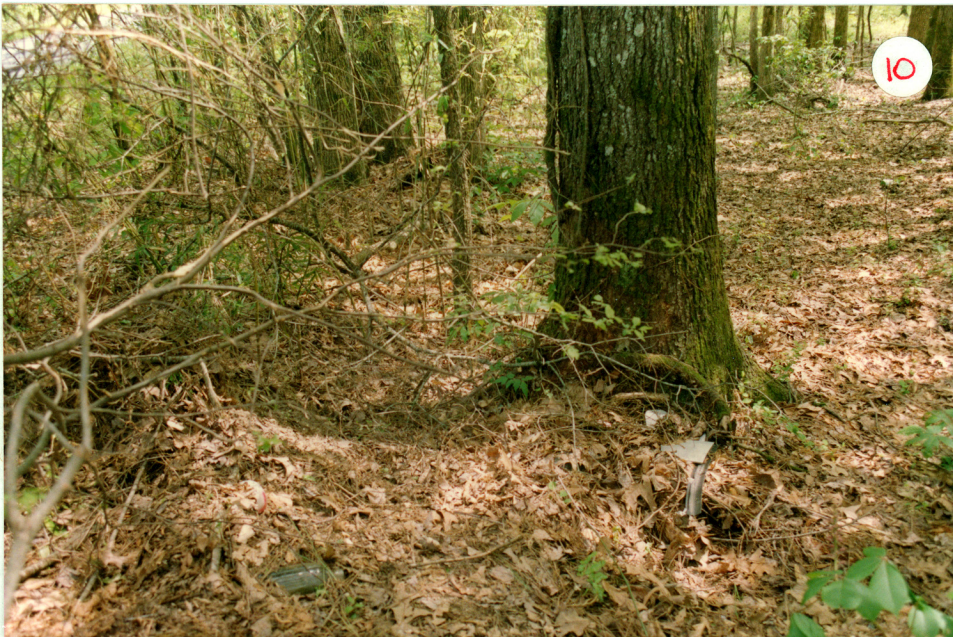
10. Impact area with the large tree. This is where the airbag deployed.

Following the sideswipe the vehicle was redirected counter-clockwise into another large tree. The frontal plane impacted the tree in the most severe impact in the collision sequence. Direct impact damage was located on the right half of the front bumper. Damage was noted to the bumper, bumper cover, right headlamp assembly, hood, and right front fender. Maximum residual crush was measured at the right front corner as 10.25 inches to the bumper. The crush measurements were as follows:

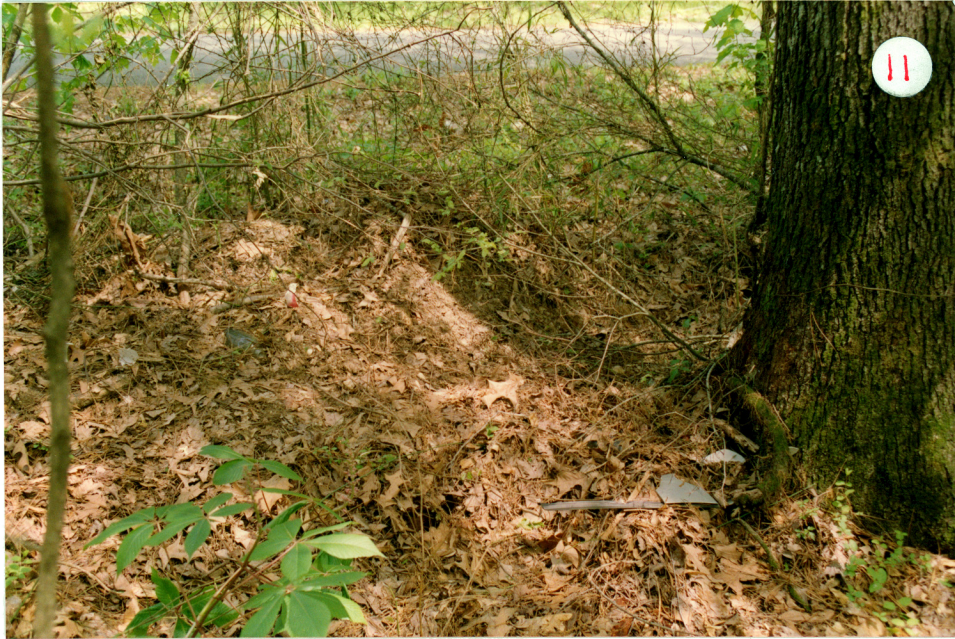
11. Final rest position of the vehicle.

Following impact with the oak tree the vehicle bounced back approximately 8 ft. and rotated clockwise. In all the vehicle traveled 151 ft. from where the initial skid mark began to its final rest position. The vehicle was 13.5 ft. west of the west road edge at final rest. The vehicle was disabled and a wrecker was called to tow the vehicle to a storage facility.

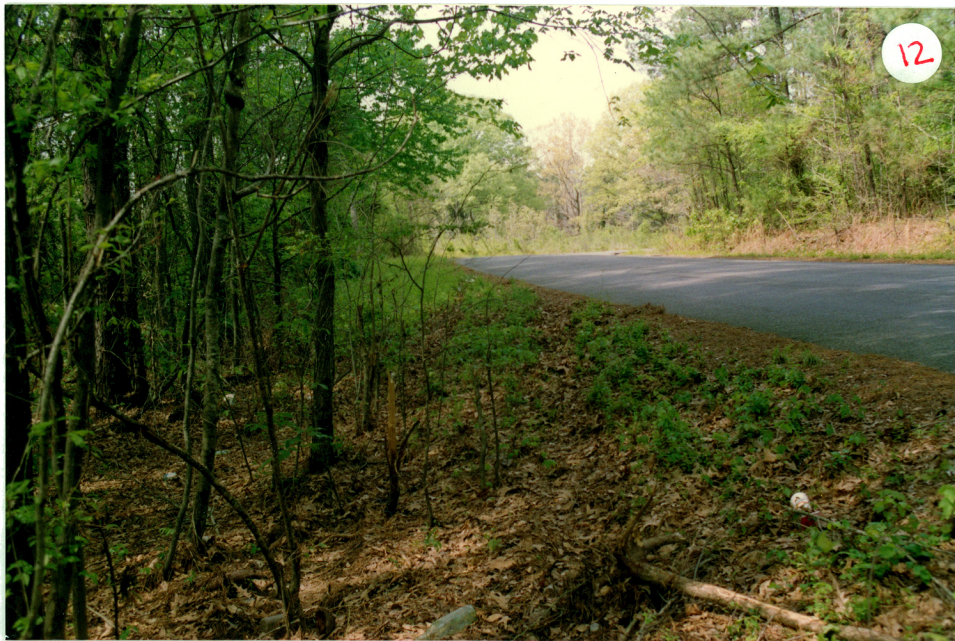
12. Opposite view showing the vehicle's path on the roadside.

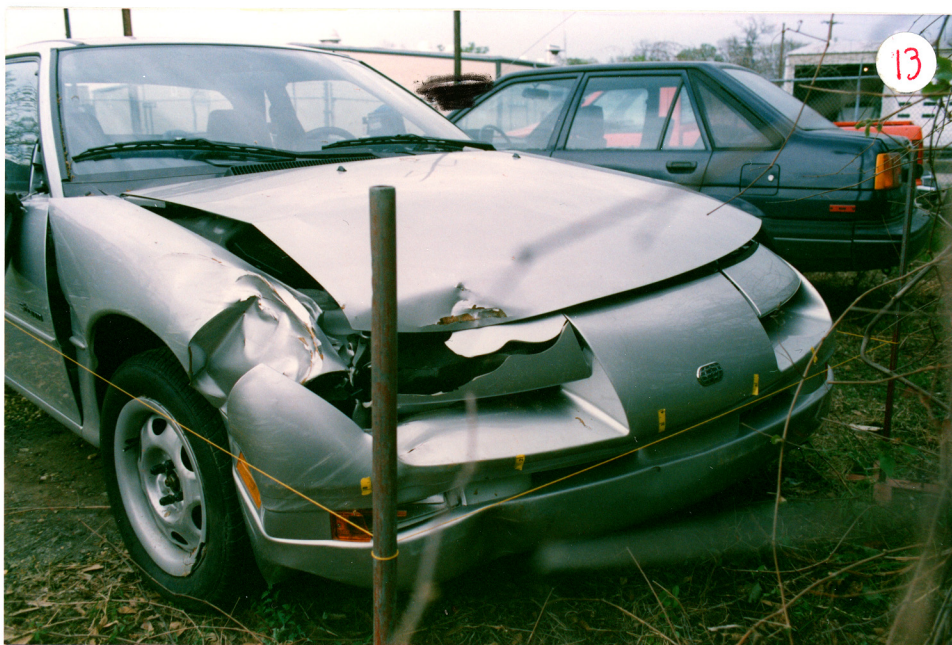
13. Frontal view of the Chevrolet GEO Storm showing the impact damage from the tree.

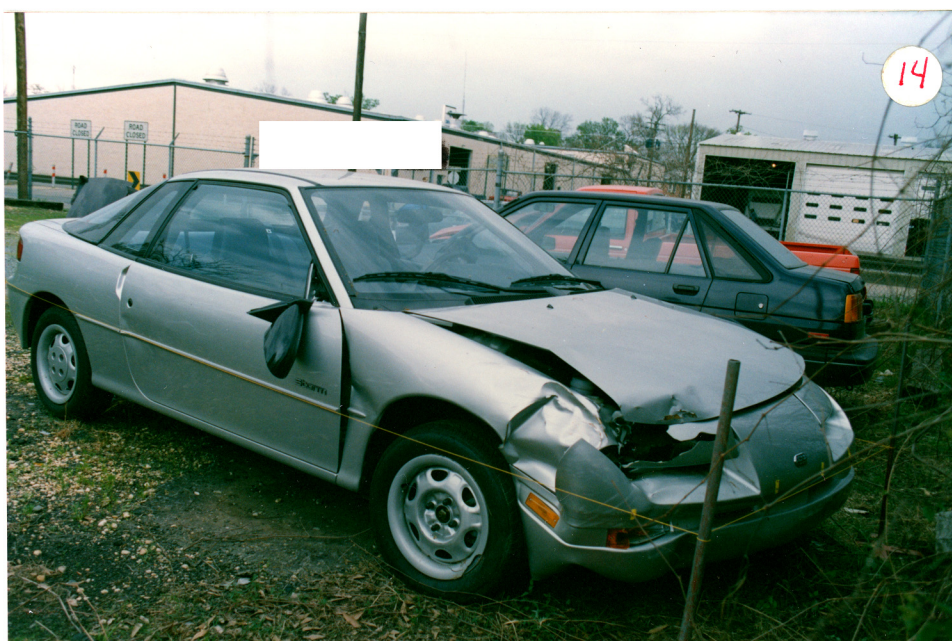
14. Front right view of the vehicle.

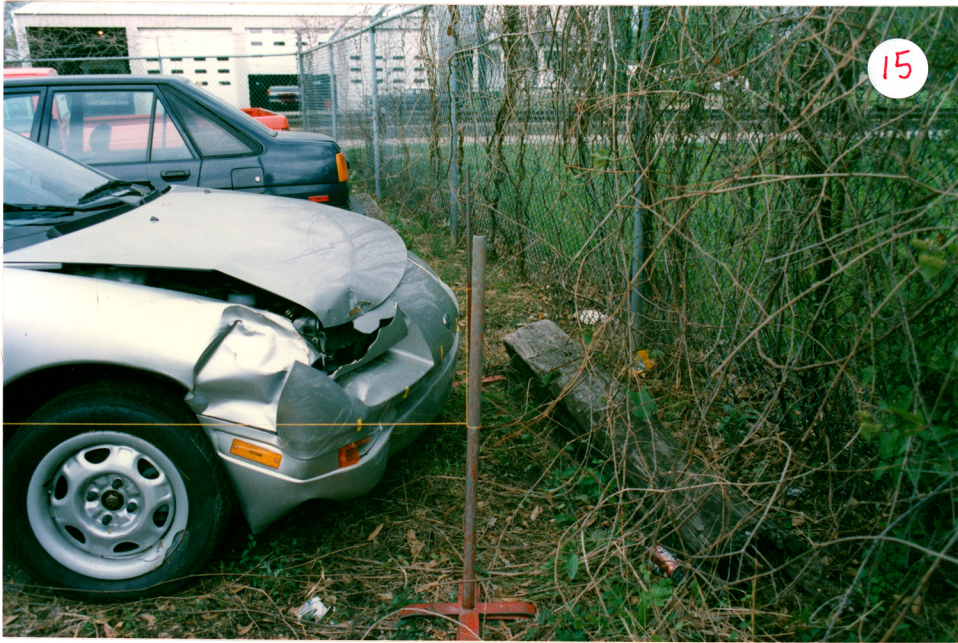
15. Right front view showing the amount of frontal crush sustained in the impact.

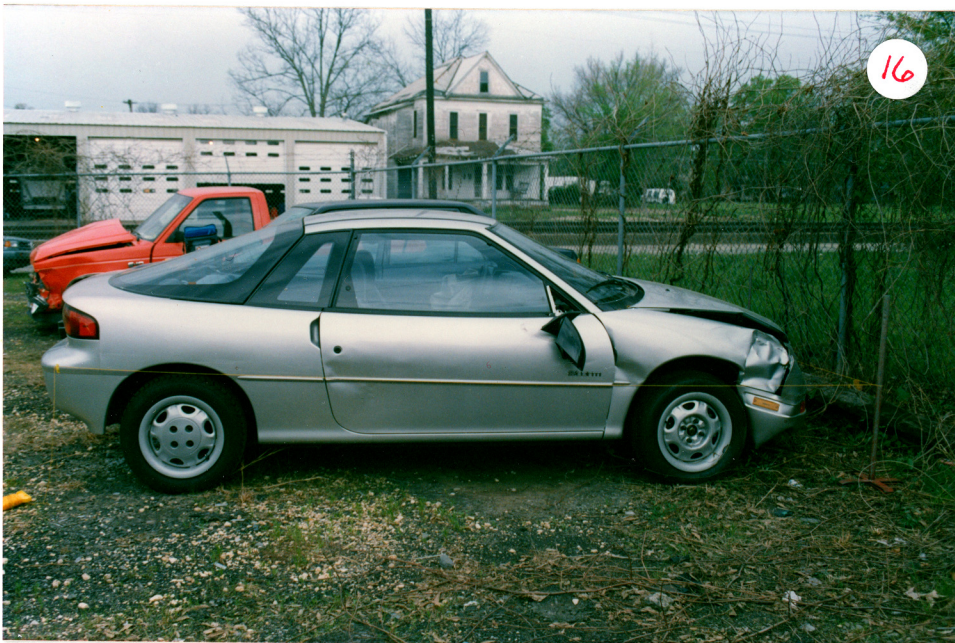
16. Right side view showing the sideswipe damage from the pine tree impact.

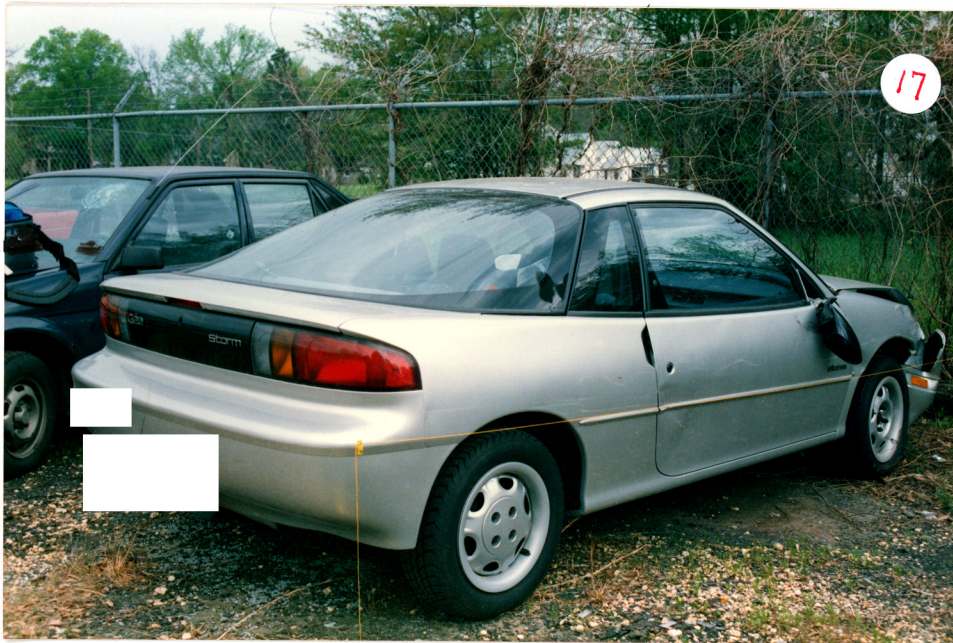
17. Right rear three-quarter view of the vehicle.

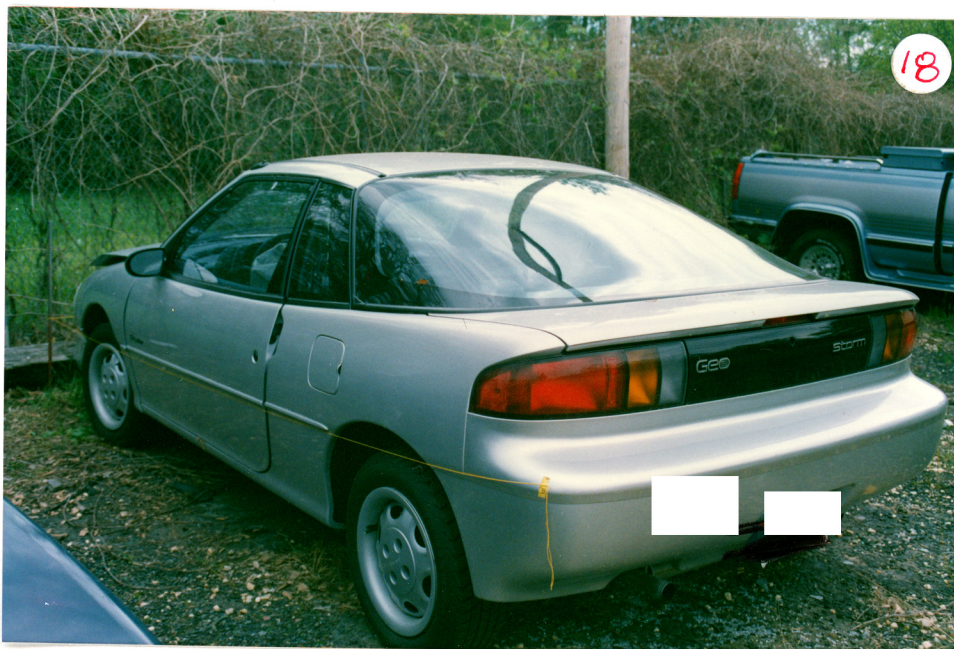
18. Left rear three-quarter view of the vehicle.

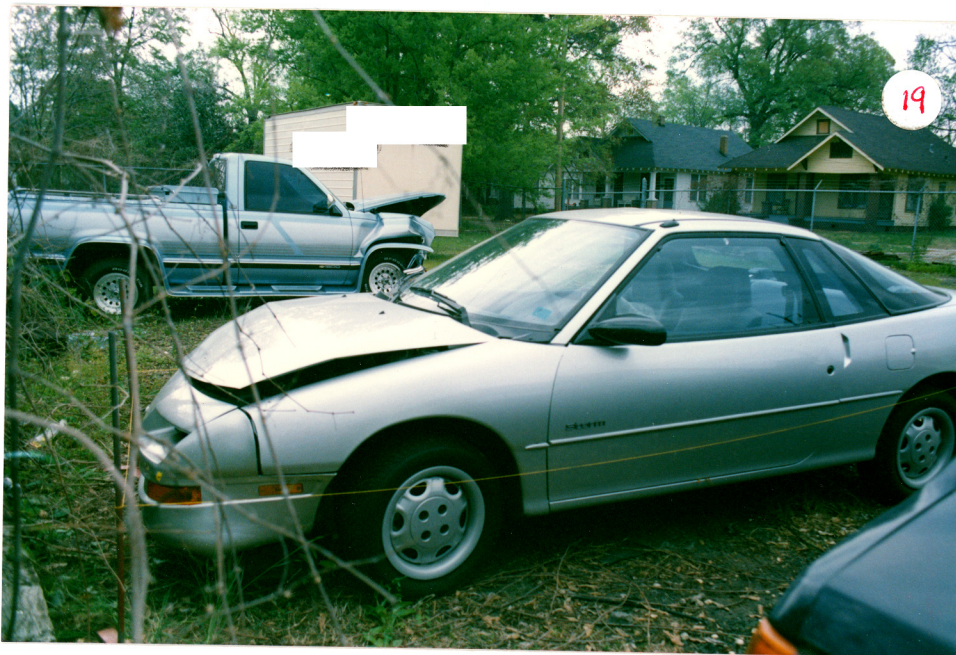
19. Left side view of the vehicle.

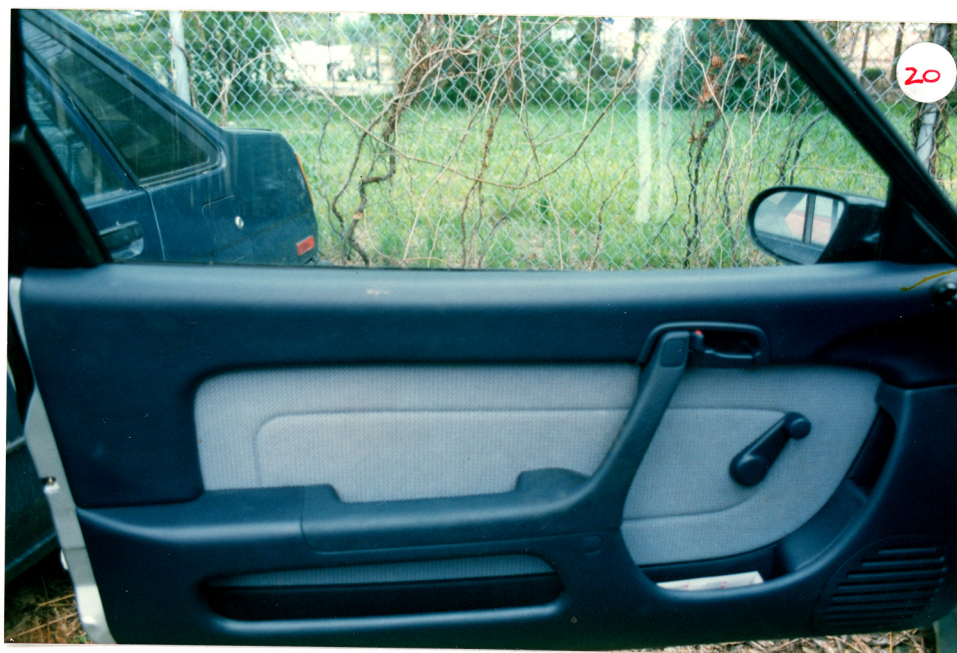
20. Interior view of the Storm showing the driver's door.

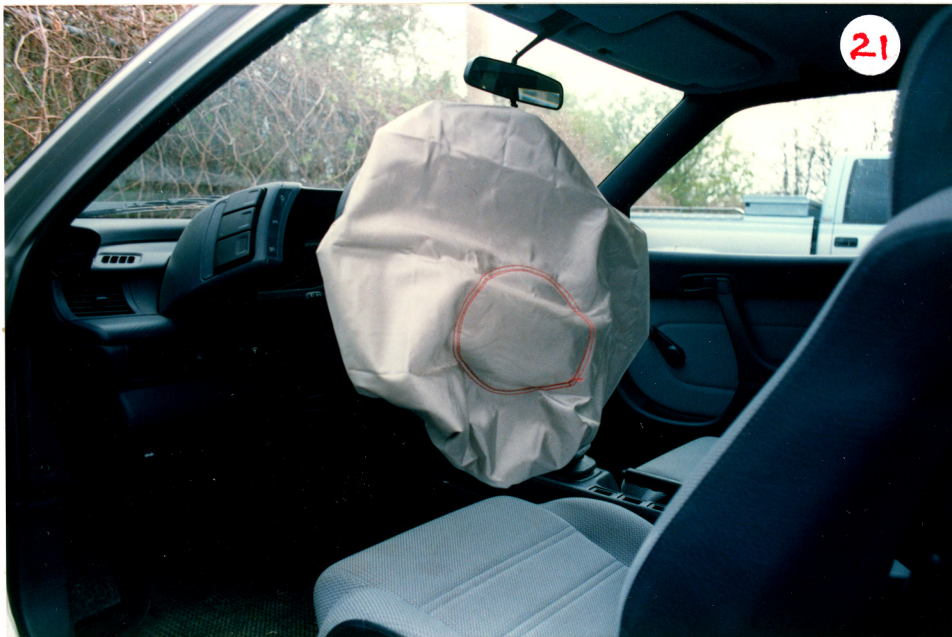
21. Interior view of the deployed airbag module in the Storm.

The interior of the airbag vehicle sustained minor damage as a result of the airbag deployment. The steering wheel module cover separated at the designated perforations. No other damage to the airbag occurred. No occupant contact points were noted and no other interior damage occurred.

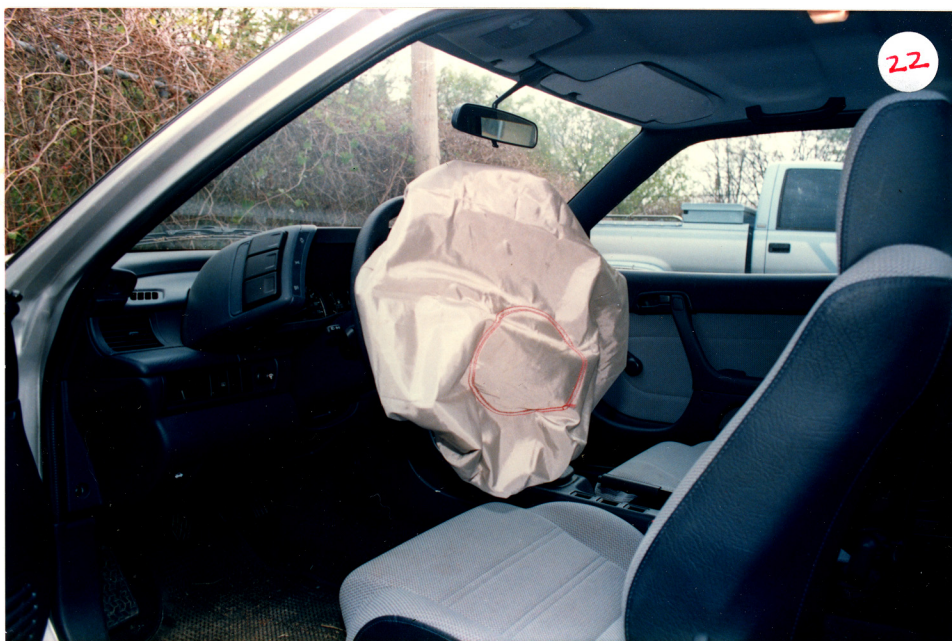
22. Additional view of the interior and deployed airbag. No occupant contact points were found.

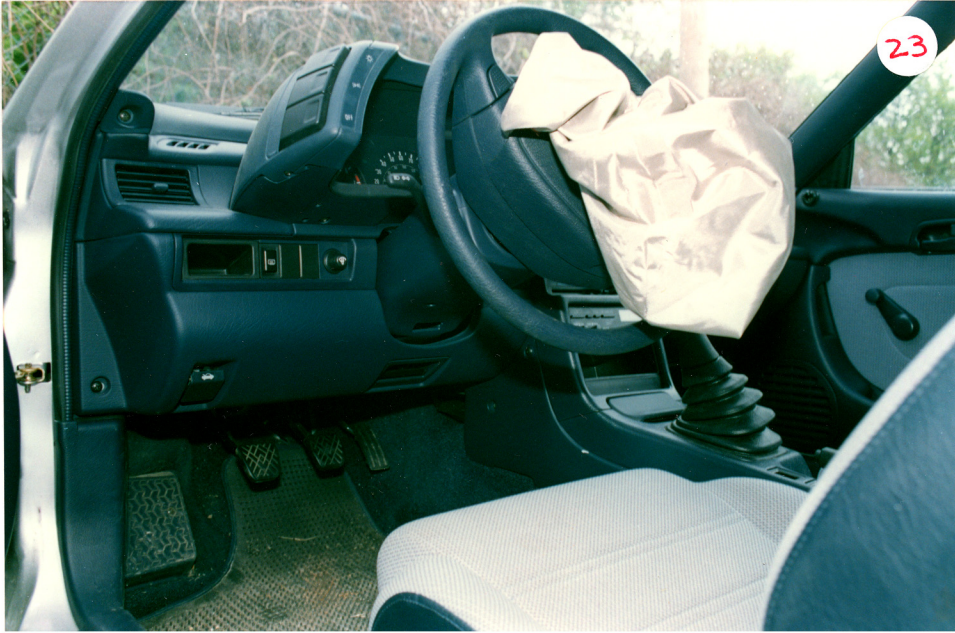
23. View of the lower dash and foot controls.

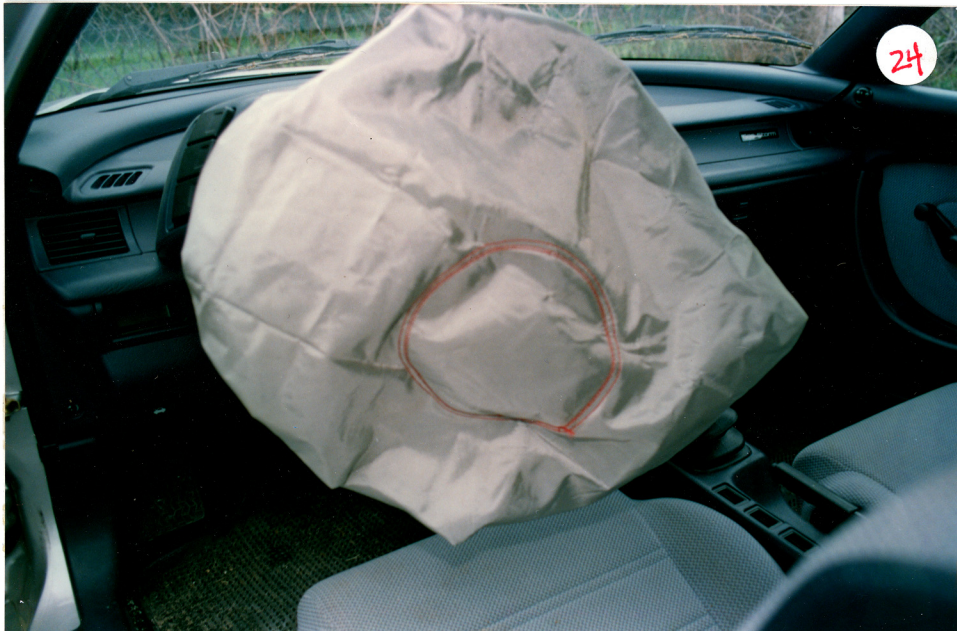
24. Close-up view of the deployed airbag.

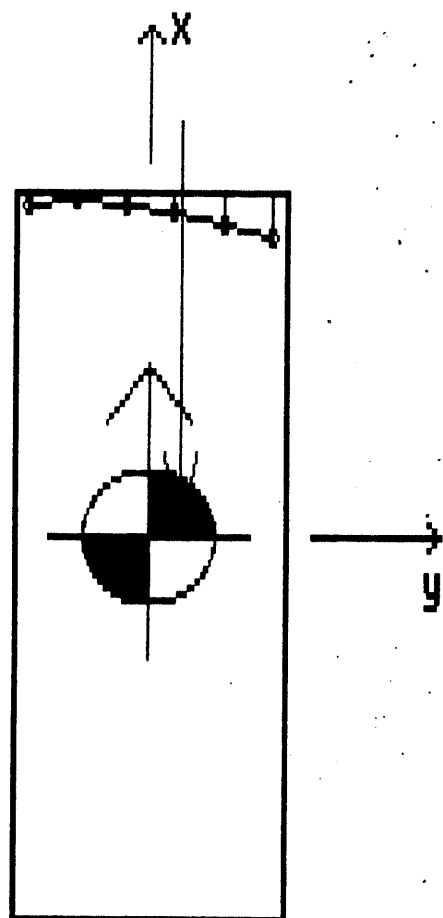
Page 2

16. Driver Presence in Vehicle 1
